Subject: LER -2003-001-00 Manual Reactor Scram (#106) Due To Loss
Of Condensate/Feedwater]

Grand Gulf Nuclear Station
Docket No. 50-416
License No. NPF-29

GNRO-2003/00015

Manual Reactor SCRAM Due To Loss Of Condensate/Feedwater

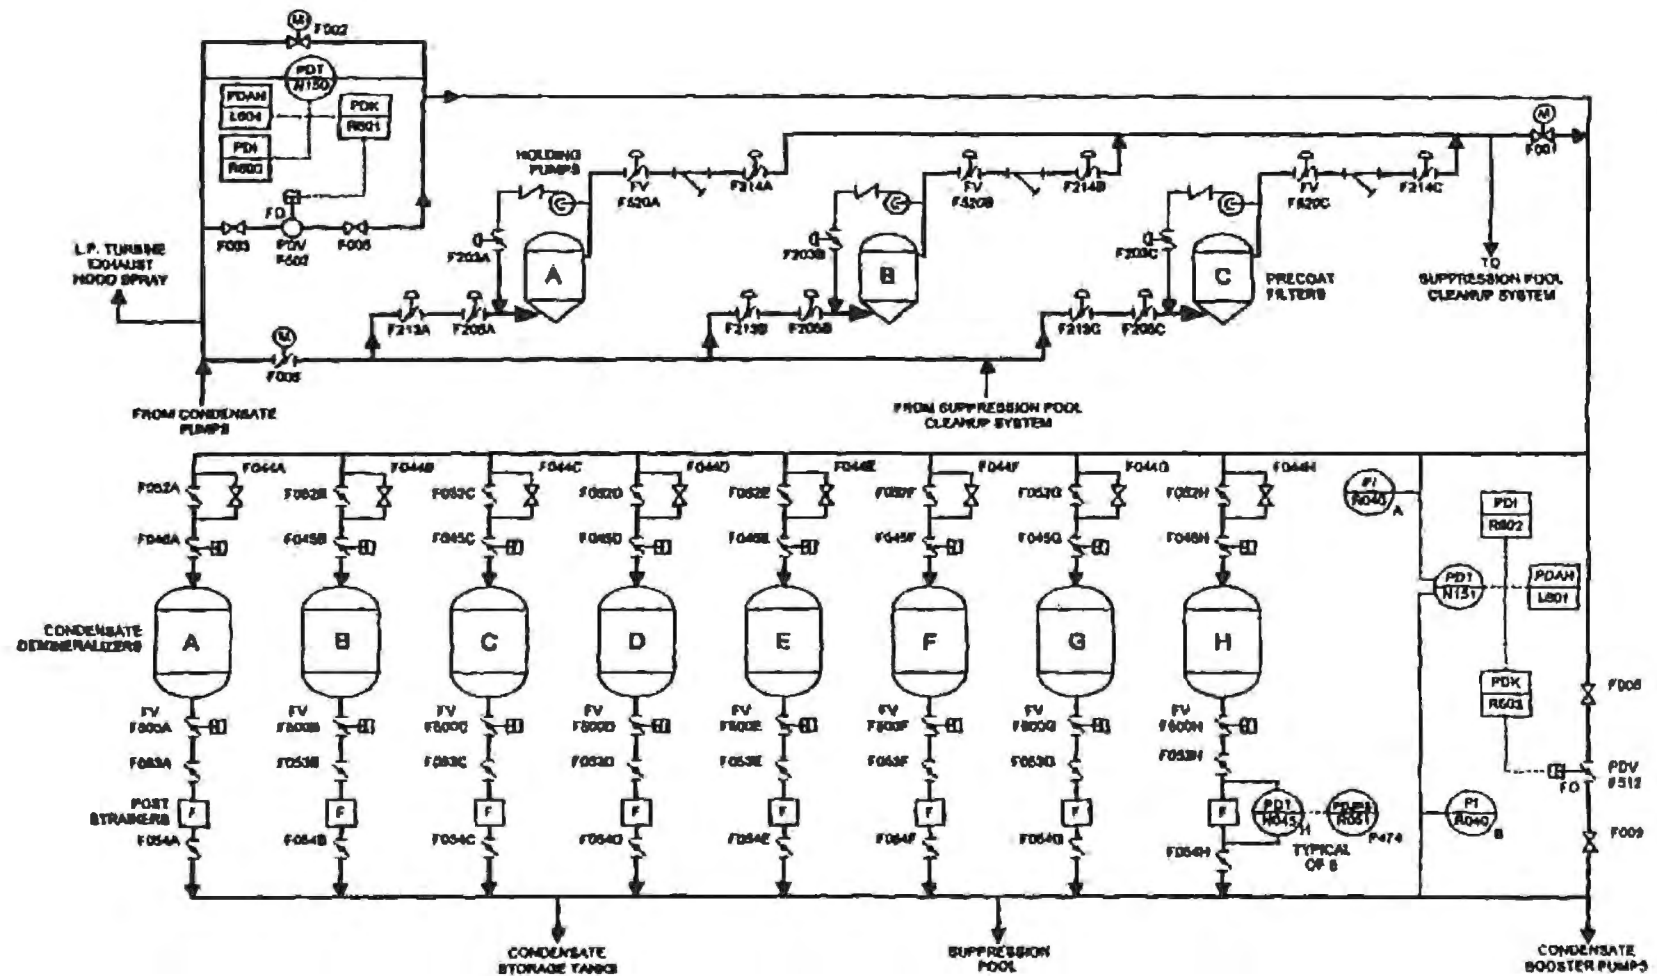
Condensate Cleanup System
Figure 1

Investigation revealed that as they seated the flexible conduit into the 45 degree elbow, an apparent pre-existing nick in the insulation failed allowing a bare wire to make contact with the grounded elbow. This caused a breaker (2L1) in the Condensate Cleanup Control Panel (1H22-P474) to trip. The breaker trip de-energized position indication for the demineralizer inlet valves. The loss of indication on the inlet valves caused the outlet valves for all in-service demineralizers to go closed.

The demineralizer outlet valves are interlocked to the inlet valves such that when the inlet valves are not full open, the outlet valves will automatically close. The other valves in the system have their indication powered directly from the 2L1 source and therefore lost all associated indication at Panel 1H22-P474.

- All demineralizer inlet valves indicated dual position
- The respective position indicating contacts for all demineralizer inlet valves opened, removing the control signal to all demineralizer outlet valves' current-to-pneumatic (I/P) controllers, simultaneously closing all 7 operating demineralizer outlet valves.

Historical design of the power supplies within the 1H22-P474 panel does not meet current design engineering practices to isolate failures to individual trains. The system is designed with a molded case breaker as a common power supply for the valve position limit switches for the eight demineralizers and the three resin regeneration tanks. There is no downstream fault isolation for an individual demineralizer or resin regeneration tank valve position. The circuit breaker supplying power to this equipment is the only fault protection.

Additionally, a change in the control system design by Startup Engineers (SFR-1-E-1875) introduced the interlock between the inlet and outlet valves that was not part of the original design. The interlock was intended to prevent inadvertent over-pressurization of the cation tank if a condensate demineralizer outlet valve was left partially or completely open. This interlock created an unintended single failure vulnerability into the controls in the event that the limit switch supply breaker should trip.

Schematic of the condensate demineralizer system.

Additionally, a modification to the condensate system to remove the interlock between the demineralizer inlet and outlet valves has been completed.
